Article

# Concrete Crack Detection and Monitoring Using a Capacitive Dense Sensor Array

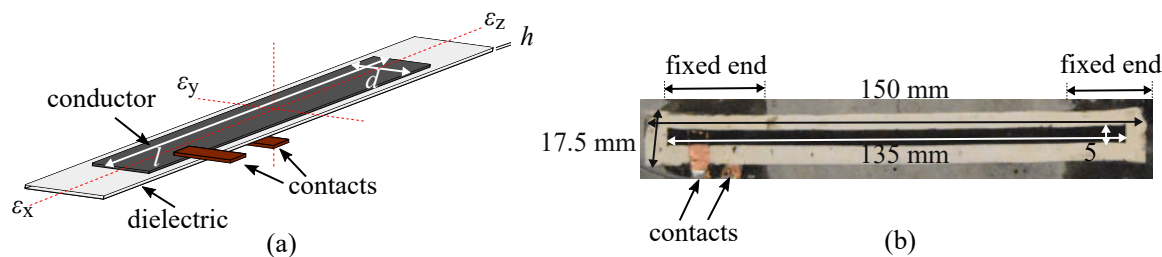
**Figure 1.** (a) Schematic representation of an SEC; (b) picture of an SEC with active sensing area measuring 135 mm × 5 mm.

The SEC is a low-cost, robust, and highly scalable thin-film strain sensor that consists of a flexible parallel plate capacitor. A given change in a monitored surface's geometry (i.e., strain) is transduced into a measurable change in the SEC's capacitance. An SEC is presented in Figure 1 with its key components annotated. The SEC is constituted from a styrene–ethylene/butylene–styrene (SEBS) block copolymer arranged in three layers. The inner layer (dielectric) is filled with titania to increase both its durability and permittivity, while the outer layers (conductors) are filled with carbon black to provide conductivity. The carbon black-filled outer layers also provide enhanced UV light protection, therefore enhancing the sensor's environmental durability [22]. The fabrication process of the SEC is covered

where  $\epsilon_0 = 8.854$  pF/m is the vacuum permittivity,  $\epsilon_r$  is the polymer's relative permittivity,  $A = d \cdot l$  is the sensor area of width  $d$  and length  $l$  (as annotated in Figure 1a), and  $h$  is the thickness of the dielectric.

Equation (1) can be specialized for the sensor configuration of interest to this paper, where the sensor is glued at each end and free-standing in the middle, as shown in Figure 1b, undergoing uniaxial strain ( $\epsilon = \epsilon_x$ ):

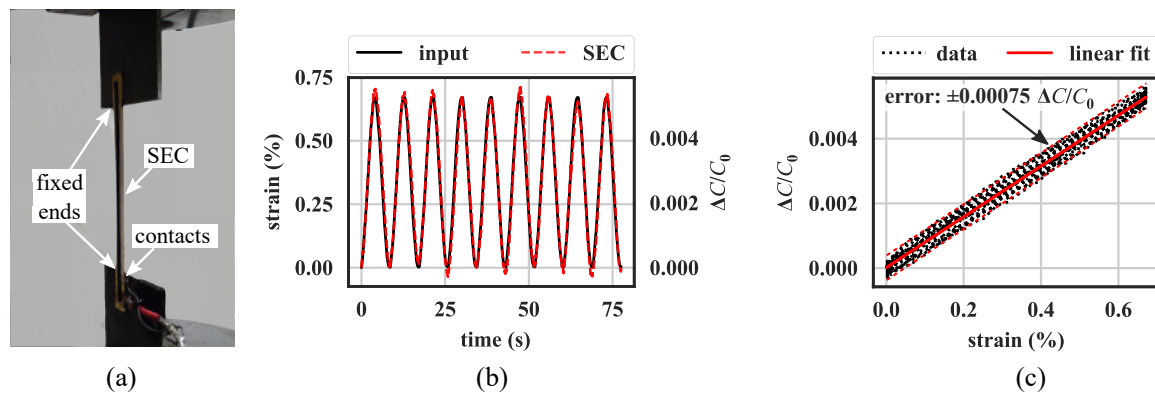
**Figure 2.** (a) Experimental gauge factor characterization test setup; (b) capacitance time history response subject to cyclic strain input; and (c) sensitivity and linearity of the sensor.

The electromechanical response of an end-bonded SEC (as shown in Figure 1b) was investigated by applying an axial 0.12 Hz cyclic excitation on a free-standing specimen using a servo-hydraulic testing machine, as shown in Figure 2a. During the test, the SEC's capacitance was recorded at 24 Hz using a custom-built data acquisition device (DAQ), and the displacement response was recorded at 600 Hz from the dynamic testing machine. Figure 2 presents the results of the electromechanical test, comparing the measured strain (black line in Figure 2b) and the corresponding change in capacitance measured by the SEC. Figure 2c reports the change in capacitance as a function of the change in strain. As shown in Figure 2c, the strain and measured change in capacitance have a linear relationship that when fitted with linear least squares regression can be used to obtain the gauge factor  $\lambda = 0.78$  over the tested range 0–0.7% strain. Figure 2c shows the capacitance error bound ( $\pm 0.00075 \Delta C / C_0$ ), equivalent to a resolution of 9.6  $\mu\epsilon$ .

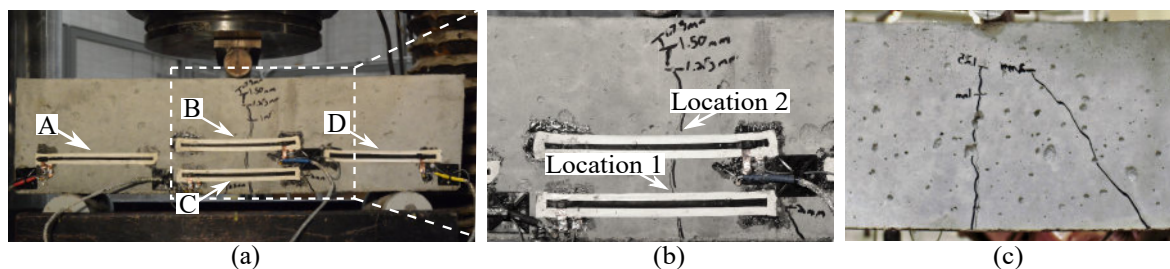
**Figure 3.** (a) Crack patterns on the small-scale reinforced concrete beam; (b) an enlarged view of the cracks on the front side of the specimen; and (c) an enlarged view of the cracks on the back side of the specimen showing a shear crack.

Figure 3b is a picture of the final crack pattern, and Figure 4 plots a time history of data. Note that the magnitude of strain in Figure 4 is very high, because it represents the strain experienced by the sensor spanning the crack opening. The gray dashed lines in Figure 4 show when the machine paused and resumed to produce incremental loads. The testing machine did not maintain a stable load while paused. This was confirmed through the analysis of the load-displacement curve of the specimen, along with the normalized crack width amplitude obtained by averaging the crack width at the top and bottom edges of the SEC (Figure 3a). For low levels of displacement, a single crack formed initially at the bottom-center of the beam. This single crack formation was confirmed through the slight drop in the load-displacement curve (the blue solid line between the third and fourth gray dashed line from the left in Figure 4a), along with the opening of the crack at mid-span (termed Location 1, illustrated with green dots, and Location 2 on top of Location 1 illustrated with orange triangles in Figure 4a). The flexural crack propagated to the compression zone, with a decrease of stiffness, up to a 2 mm displacement. There is a loss of capacity around 1.9 mm (second blue solid line in Figure 4a) which was produced by a shear crack opening on the back side of the concrete specimen (Figure 3c). From then up to 3.6 mm, the load remained constant. This behavior was almost completely captured by the SEC

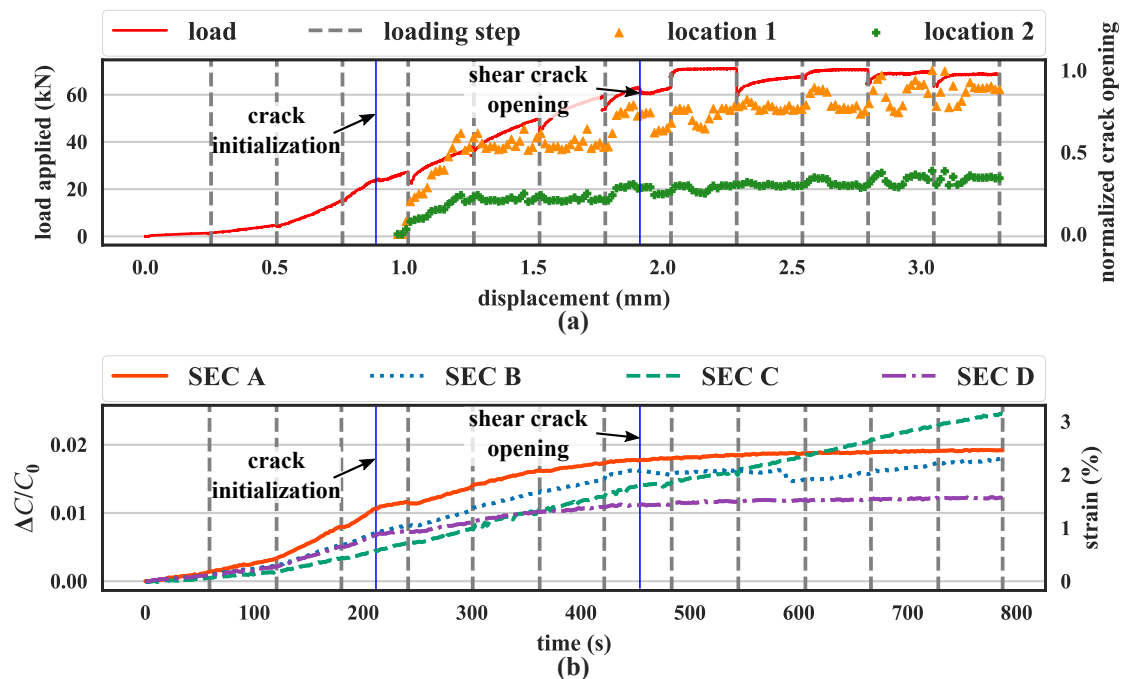
**Figure 4.** Time series results from the small-scale reinforced concrete beam: (a) load-displacement curve and normalized crack opening widths histories; and (b) relative capacitance and computed strain histories for all four SECs.

network installed on the specimen. As shown in Figure 4b, SECs A, B, and D have a decrease in slope that matches the one associated with the formation of the first flexural crack. At the initialization of the backside shear crack, SEC B was able to capture this behavior as a drop in its capacitance followed with an unstable capacitance growth (the second blue solid line from the left in Figure 4b), which may be associated with stress redistribution. One can also observe that SEC C, mounted at the bottom of the tension zone, should have the highest strain value/relative capacitance change, but it has the lowest change in relative capacitance at the initial stage. This could be attributed to strain transfer at the sensor interface caused by the installation procedure, which cannot be quantified directly, but does not significantly affect its capability to measure crack [27].

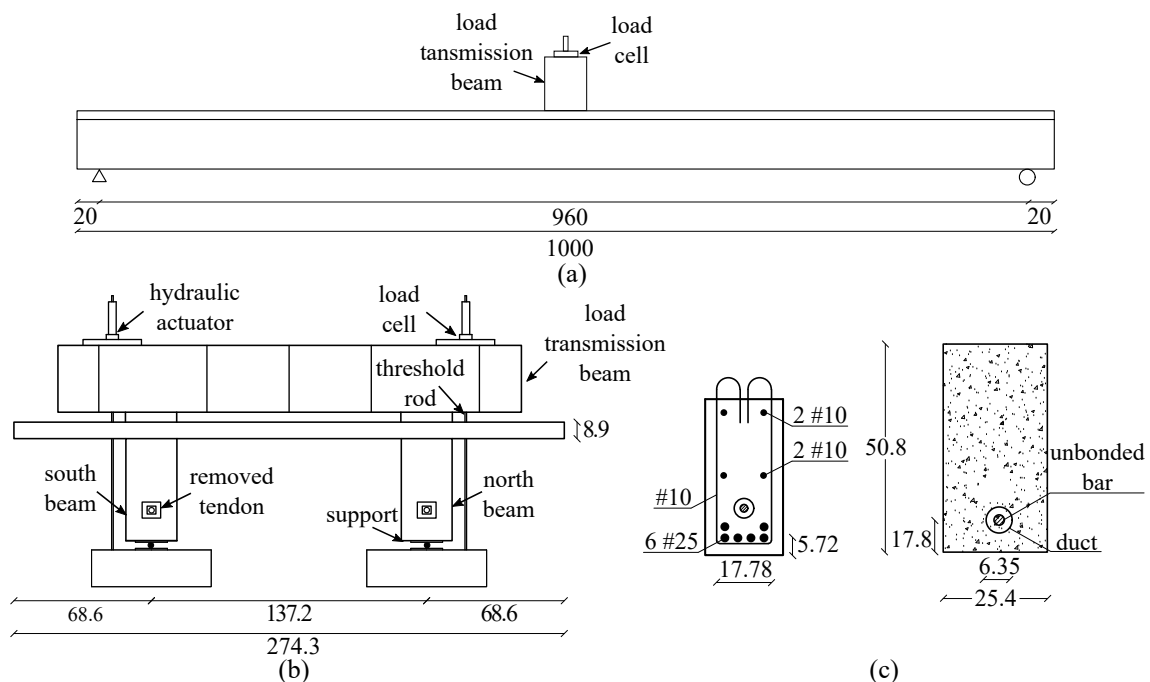
**Figure 5.** Detailing of the tested specimen: (a) elevation view; (b) typical cross-section; and (c) reinforcement distribution and cross-section design of a beam (dimensions are in cm).

Each beam has a rectangular cross-section of 254 mm  $\times$  508 mm, a length of 10 m, and a clear span of 9.6 m, as illustrated in Figure 5. The beam dimensions were designed to limit the first natural frequency of the full system below 12 Hz, which is a typical value for short-span bridges. A 391 kN post-tension force was applied to both beams before the casting of the connecting deck to avoid early cracking under self-weight. A circular plastic duct of 63.5 mm was installed in the cross section with its center located at 178 mm from the bottom face of the beam to accommodate a single

post-tension bar of 25.4 mm diameter. The sections were reinforced using 6 reinforcement bars with a diameter of 25.4 mm, with their positions indicated in Figure 5 to provide high ductility of the girders. The deck connecting the two girders had a width of 3 m, thickness of 9 cm, and length equal to that of the beams (10 m). The deck was designed to ensure that cracks would only form on the girders, except around ultimate strength. The deck was reinforced using two layers of reinforcement bars of 12.7 mm diameter under both the bottom and top surfaces. The beams were positioned at 1.4 m from each other, leaving an overhang of 70 cm on each side as shown in Figure 5b. The structural system was loaded using hydraulic actuators (Figure 5b) installed over a beam transmitting the actuator force to the beams' centerline. The girders and the deck were casted in Iowa State University's Structures Laboratory using a self-compacting concrete with specified compressive strength of 41 MPa and 28 MPa, respectively. During tests, the measured compressive strength for the girders and deck were 48 MPa and 28 MPa, respectively.

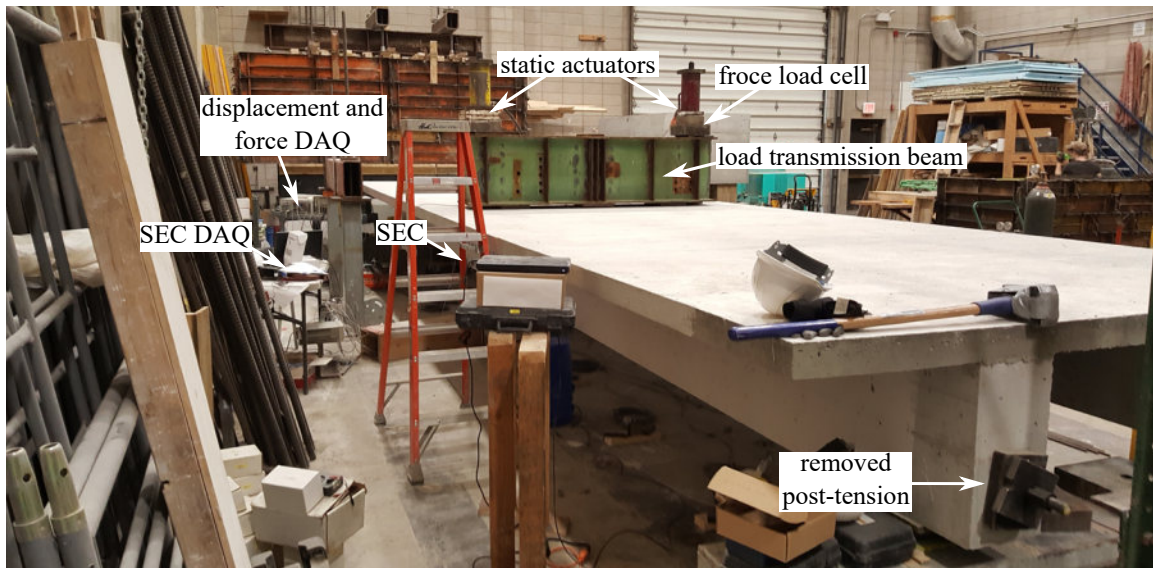
Figure 6. Picture showing the experimental setup of the large-scale post-tension beam test setup.

The experiment was conducted in two sequential phases. In the first phase, the prestress was released at one side of the beam (Figure 6) to provide differential damage. In the second phase, a load was applied using the pair of hydraulic force actuators installed on top of load transmission beam (Figure 6), and a load cell was used to constantly monitor the applied load. Loading and unloading sequences were designed to generate damage to the beams in increasing severity. Visual observations were conducted during the unloading phases. Figure 7 is a plot of the loading history.

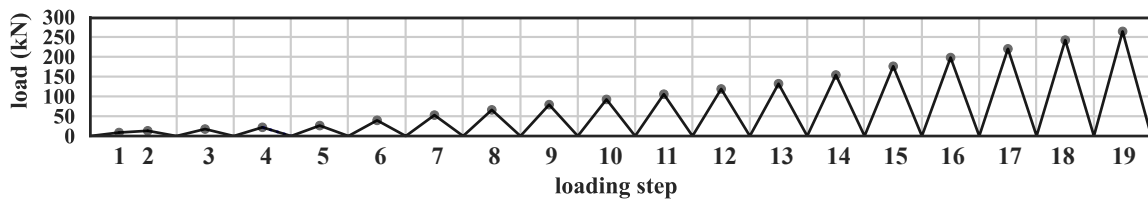
Figure 7. Loading-unloading sequence for the load test.

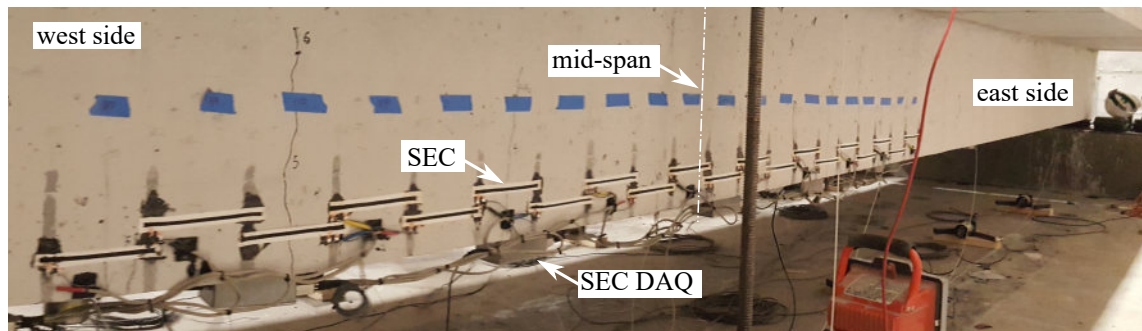
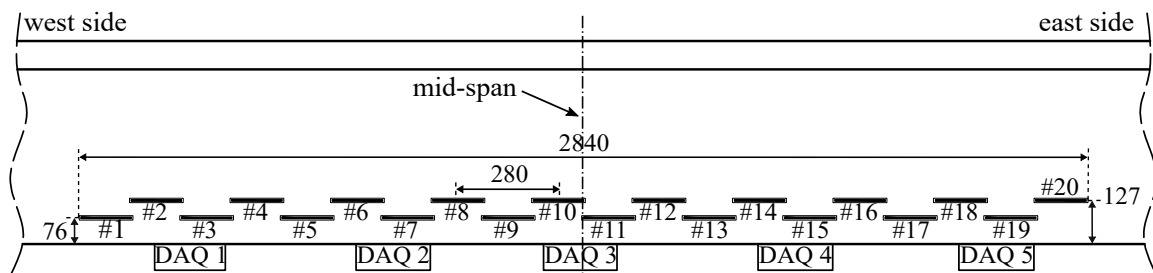
Figure 8. Sensor instrumentation around the midspan of the beam: (a) picture; and (b) schematic of sensor locations, partial beam elevation (dimensions are in mm).

portion of each sensor was narrowed to the unglued section. The numbering scheme of the SECs is shown in Figure 8. Capacitance data collected at 24 Hz using a customized DAQ (Figure 8) driven by a LabVIEW code.

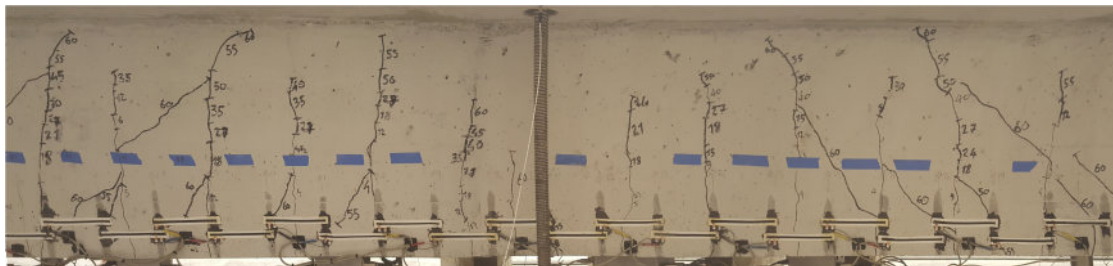
Figure 9. Picture of crack pattern before reaching ultimate strength after loading step 19.

Figure 9 is a picture showing the crack pattern at the end of loading step 19, with visible cracks traced using a black marker. The beam experienced uniformly distributed transverse and shear cracks at both two ends. The area under the loading point experienced shorter cracks, which is as expected, given the pressure from the flange restraining the crack growth. Cracks were observed in the loading zone under SEC #9, and #12 after loading step 2, under SECs #6, #7, #15, #16, #18, and #20 after loading step 3, and under SEC #1, #3 after loading step 4. Subsequent loading steps 5 to 17 induced a uniform formation and growth of flexural cracks along the span of the girder. Rapid formation of shear cracks crossing different SECs at both ends, from SEC #1 to #7 and from SEC #16 to #20, occurred after loading step 18 and 19.

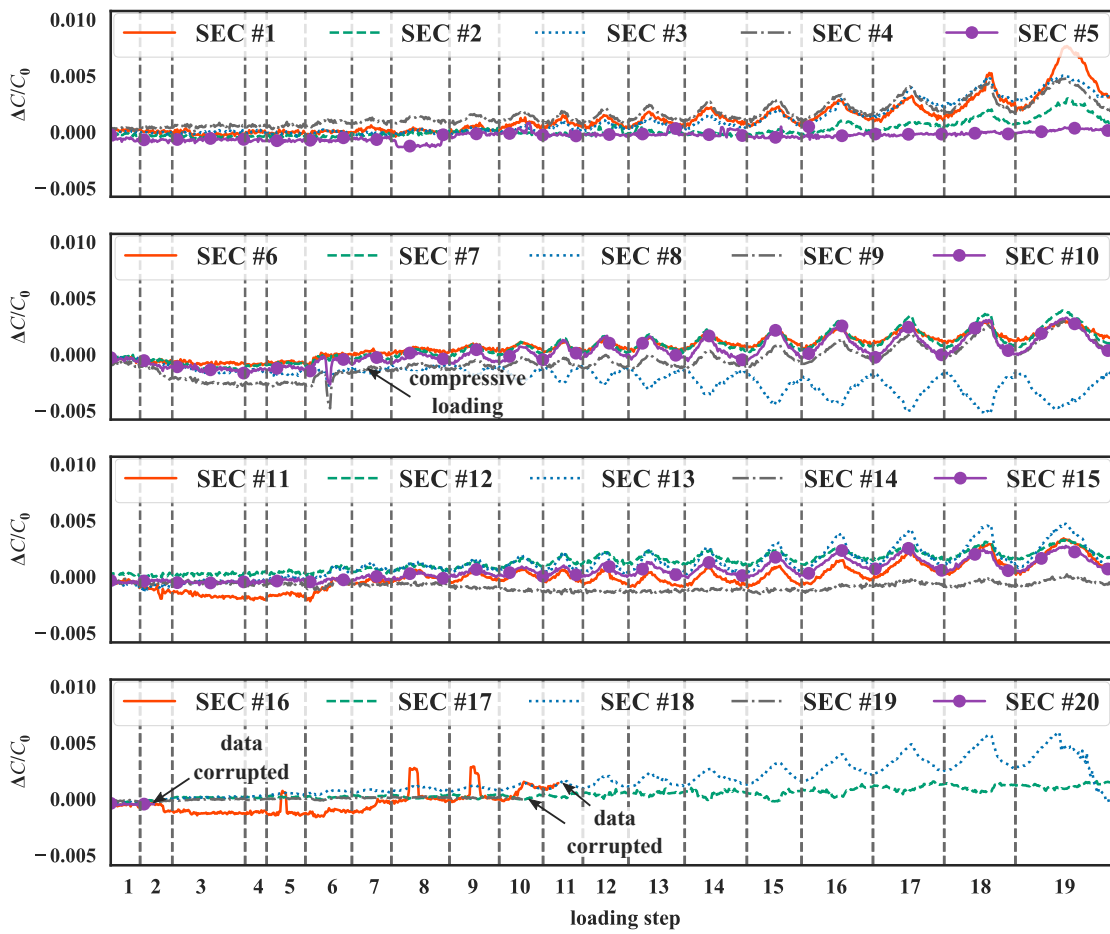
Figure 10. Time histories of strain measurements for all SECs.

Figure 10 plots the time evolution of the relative changes in capacitance  $\Delta C/C_0$  during the loading test, where the gray dashed lines indicate when the machine paused after each incremental loading step was produced. Negative  $\Delta C/C_0$  values indicate compression, while conversely a positive value indicates tension. Results are presented after the replacement of outliers with averaged values and the application of a low-pass Butterworth filter with a cutoff frequency of 2 Hz. SECs #16, #19 and #20 experienced corrupted data after a crack formed under the epoxy adhering the sensor to the beam.

SEC #8 exhibited a negative capacitance change and an inverse loading-unloading shape. This disagreement between the capacitance change and loading was caused by localized compressive strains induced by the splitting of the specimen along the flexural crack. This splitting in the specimen caused the right-hand-side portion of the crack under SEC #7 to move towards the right, thus resulting in compressive loading of the concrete under SEC #8. This behavior was confirmed when the flexural crack opened under SEC #9 at loading step 8, at which point the amplitude of the maximum cracks began to increase significantly. A similar, yet smaller in magnitude, compression behavior was observed from SEC #17 that was located between two cracks. Under loading step 5, the relative capacitance did not change significantly and the compressive effect induced from the flange at the center of the beam was captured by most SECs. The loading-unloading patterns in relative capacitance changes were observable in SEC readings after a crack formed under that particular SEC.

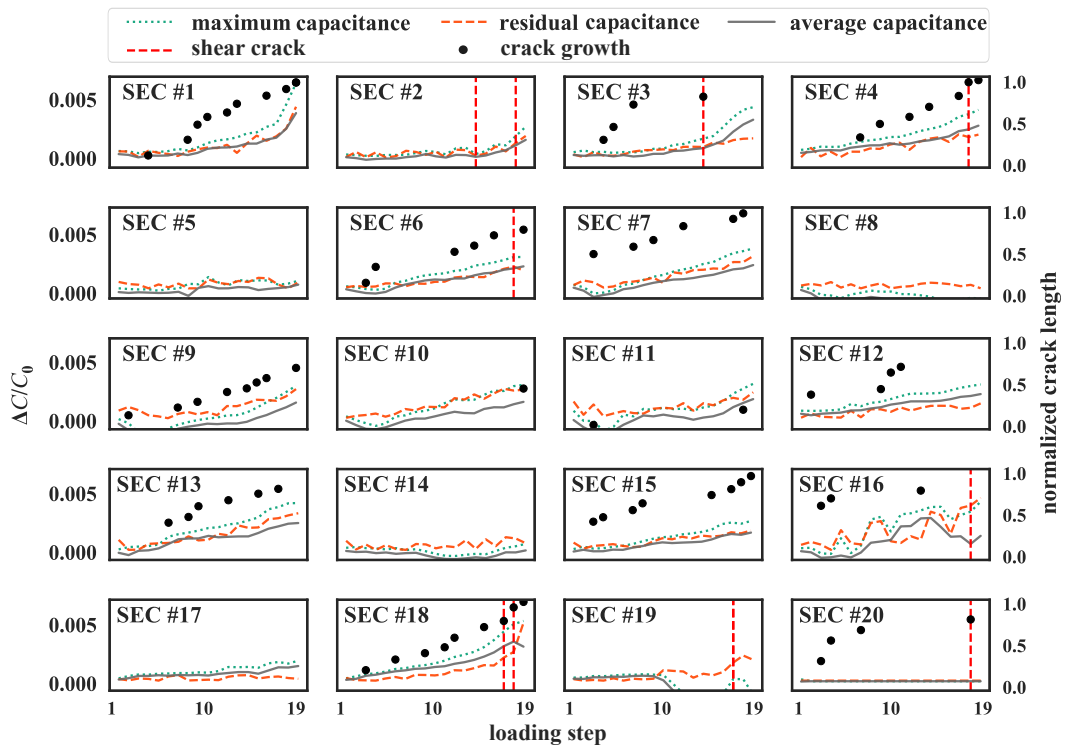
Figure 11. Comparison of maximum, residual, and average relative change in capacitance measured by the SECs and normalized crack growth length under each loading step (loading step 1 to 19).

In order to evaluate the performance of the SECs at quantifying crack openings, the relationship between crack growth and relative capacitance change was investigated. Three features were extracted from time series data to associate with crack length: (1) maximum relative change in capacitance, taken as the peak-to-peak amplitude in signal for each load step; (2) residual relative change in capacitance, taken as the difference between the maximum reading during a given load step and the capacitance left after unloading; and (3) average relative change in capacitance, taken as the average change in capacitance over a loading step. Figure 11 plots the maximum relative change in capacitance (green dotted line), residual relative change in capacitance (orange dashed line), average relative change in capacitance (gray line) against crack growth (black dots) from each loading step (L1 to L19) and SEC. The red dashed lines indicate the visible shear cracks initiation underneath the corresponding SECs. The crack length was measured as a straight line between the extremities of a crack, and normalized by the height of the web. An agreement is observed between the three features and crack growth.

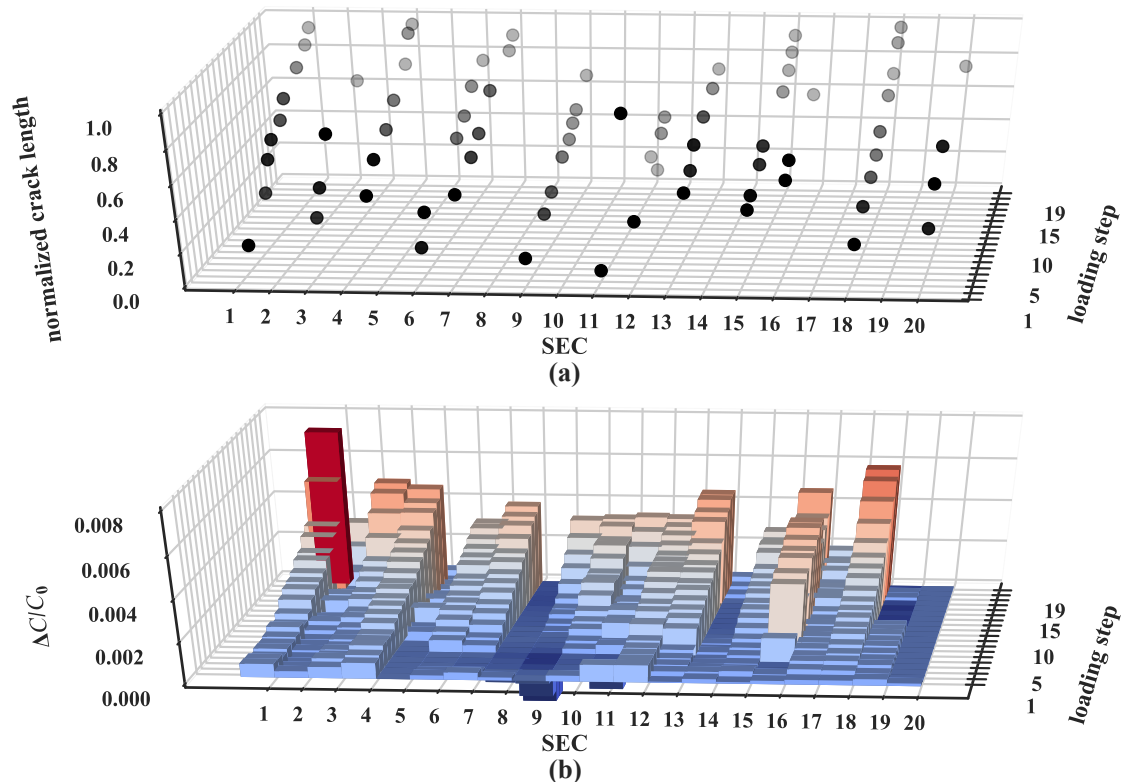
**Figure 12.** (a) Normalized crack length as a function of SEC location and loading step; (b) maximum relative change in capacitance change as a function of SEC location and loading step.

Figure 12 illustrates a compilation of the normalized crack lengths and the feature “maximum relative change in capacitance” extracted from each loading step for all the SECs. It can be observed that the feature is generally consistent with the location of a crack and its normalized length. At small strain (low loadings), this relationship is harder to distinguish. A significant change in the feature is associated with a rapid growth of the shear crack and final fracture, shown as tall red bars at the two corners of Figure 12b (SEC #1 and #18). Both small and negative changes in the feature indicate that no crack formed.
