## Assessment of Levees Using Field Instrumentation and Geophysical Methods.

OMER ALZEGHOUL , AUDRIKA NAHIAN, SADIK KHAN, JASIM IMRAN, AUSTIN DOWNEY, LAURA MICHELI

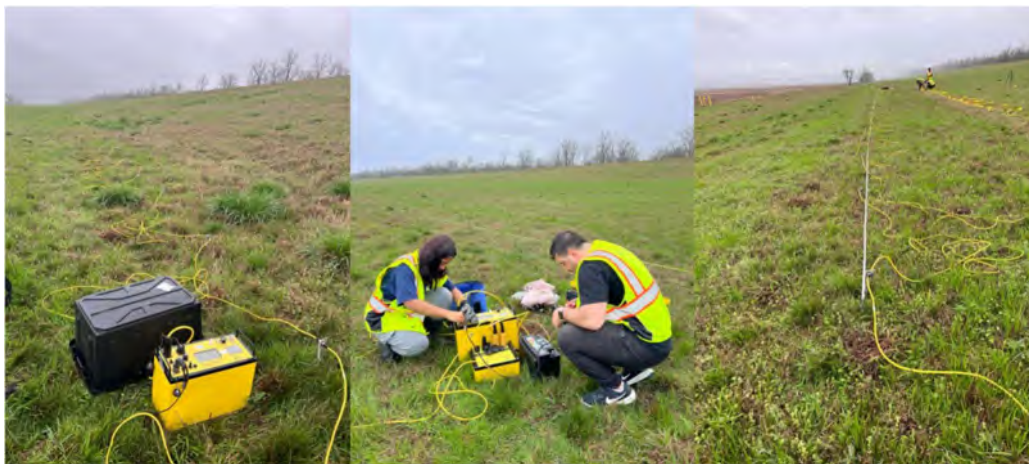
Figure 3. ERI test equipment and survey line placement.

An ERI test was performed to examine the surface resistivity of the shallow subsurface on the levee landside slope and toe of the two sites. The study was conducted by performing three different ERI survey lines at each site during spring and summer. The equipment used for the study is a SuperSting R8/IP resistivity meter manufactured by Advanced Geosciences Inc. (AGI). The SuperSting R8/IP is a multichannel system that includes 8 channels to conduct the survey and has 8 receivers that can take 8 readings for each current injection reading. To run this multichannel system a total of 56 electrodes were used. The electrodes were hammered at least 6 inches into the ground and spaced at 5 ft. center to center spacing covering 275 ft, the depth of penetration for the ERI test is a function of the electrodes spacing, since the targeted depths are the top 30ft of soils and with the 5ft spacing ERI can penetrate to depths around 60-70ft which serves the goals of the investigation. length for each ERI 2D survey line. The electrodes were connected through cables on a dipole-dipole array. Line A was located at the top of the slope near the crest and the second line B was located at the middle of the slope and line C was located at the levee toe for both sites.

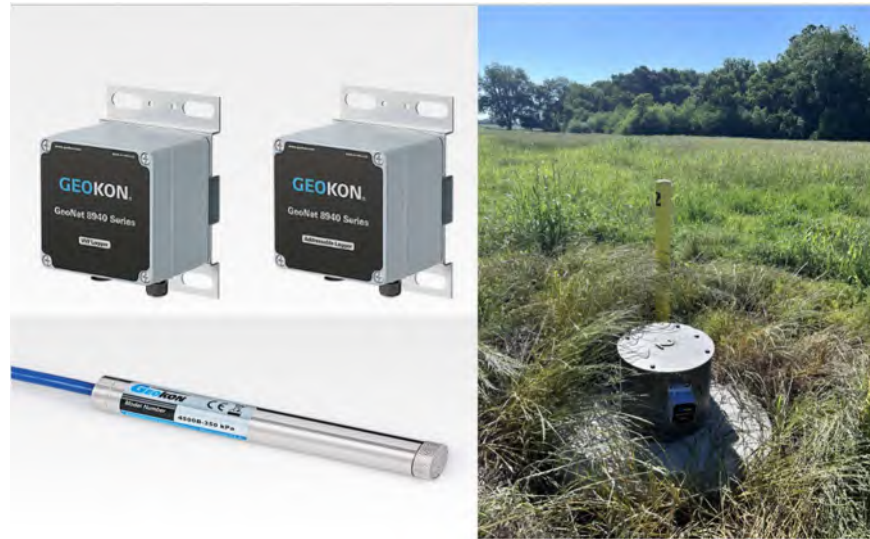
Figure 4. (a) Geokon 8940 series data logger (b) Geokon 4500B VW Piezometer sensor (c) Piezometer installation at Norfolk 1 site.

A vibrating wire (VW) piezometer sensor was installed at 48ft depth on each site to monitor the fluctuation of the water table in the levee foundation with the change of the river stages over time. The sensors are installed in the relief wells at the landside levee toe of each levee section. The sensors are connected to a data logger placed at the side of the relief well screen. The data is recorded every 15 minutes increment. The pressure readings collected by the piezometers were converted to total head and plotted against the river gage reading of the Mississippi water levels at each corresponding river mile. The data from the river gages at each river mile was interpolated between the Memphis gage (between RM 734 & 735) and the Mhoon landing river gage (between RM 687 & 688). Figure 4. Shows the used VW sensors installed in site 1.

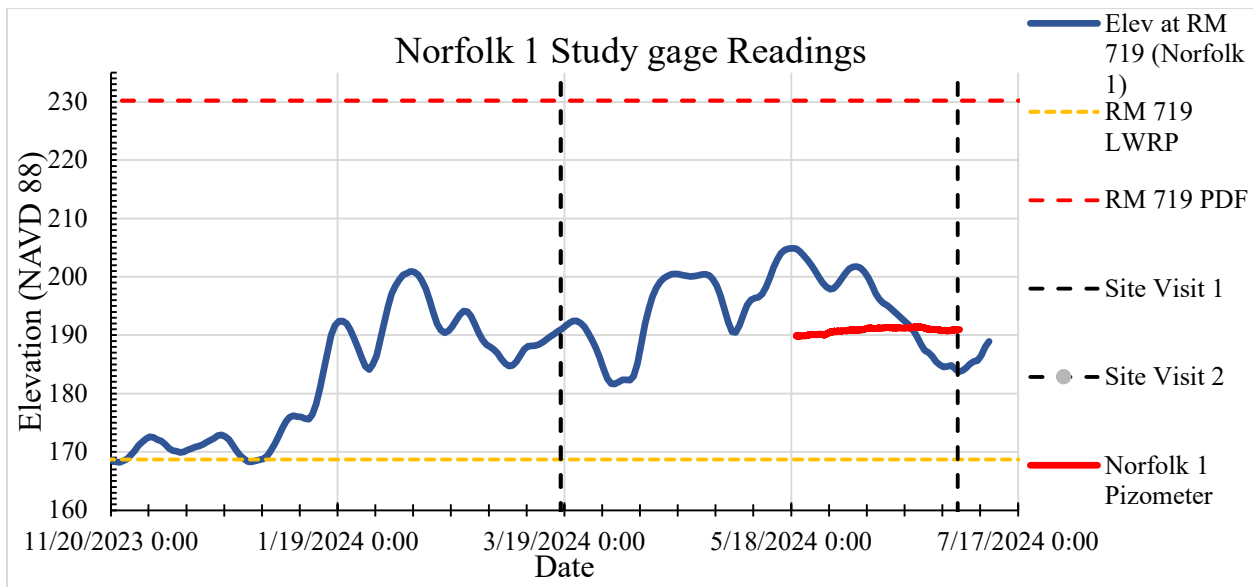
Figure 5. (a) ERI Survey Lines on March 19<sup>th</sup> (b) ERI Survey Lines on July 1<sup>st</sup> (c) Interpolated River stages at river mile 719 with piezometer sensor data.

The ERI data is taken in the spring (March 19<sup>th</sup>) and summer (July 1<sup>st</sup>) over three lines A, B, & C. Figure 5(a). and (b). represents the ERI survey data collected at each season. Figure 5(a). represents the ERI results for Line A, Line B, and Line C on March 19<sup>th</sup>, the river stage was around 192 ft. at that time, but ERI Line C shows high resistivity values 70-170 ohm-meters, which indicates that the foundation soils beneath the blanket are still dry. Figure 5(b). represents the ERI results for Line A, Line B, and Line C on July 1<sup>st</sup>, the river stage was around 184 ft. at that time, ERI Line C in this case is showing lower resistivity values 20-50 ohm-meters, which indicates that the foundation soils beneath the blanket are saturated. Figure 5(c). represents the data interpolated between the Memphis and Mhoon landing gages with the data collected from the piezometer sensor. Due to the long distance between the levee toe and the Mississippi river, the change in the water levels in the soil foundation based on the piezometer sensor is not reflecting the river stages in the short term which explains the high resistivity values on March 19<sup>th</sup> while the river is at high stage.

- Norfolk 1 site, the effect of the Mississippi river stages is not reflected on the soil resistivity immediately due to the long distance from the landside toe and the river, approximately 6000ft.

- Norfolk 1 site, the changes in the water table due to the changes in the river stages is slow and it was almost at a steady stage.
- Based on the notable lag of the ground water changes Norfolk site 1, it can be hard to evaluate the effect of the river stages fluctuations using the ERI, but it can be useful to understand and back calculate permeability parameters of the foundation soils.

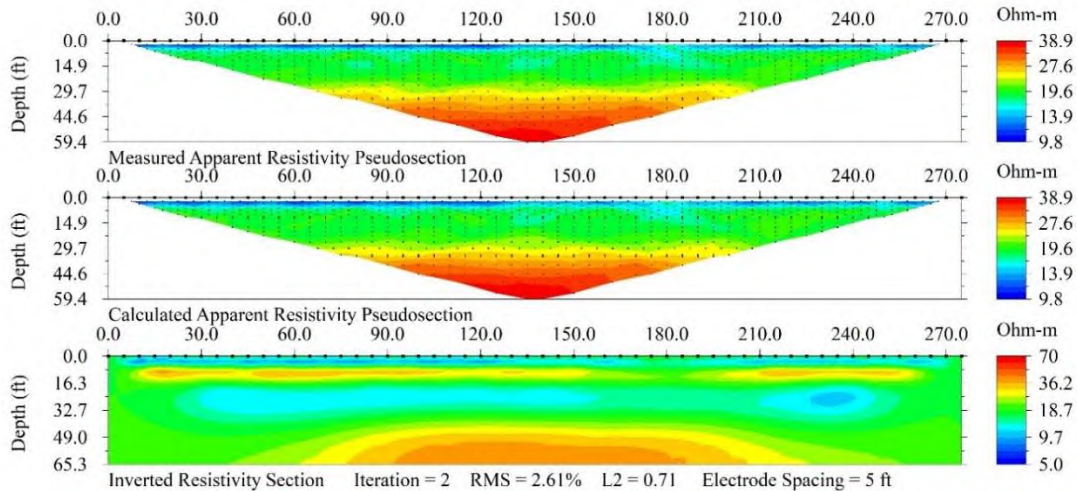
Figure 7. ERI Line C, Norfolk 2 Site inversion.

The EarthImager-2D software converts the apparent resistivity ( $r$ ) data to a 2D cross section color indexed profile using the finite element technique (FEM), the software runs an iterative process to reduce the Root Mean Squared (RMS) below 5% and to remove all noisy data.

For the first trial the software performs the inversion process using the apparent resistivity data collected from the field. Then, the model predicts certain datasets by a forward modeling process, and it compares it with the initial model and root mean square error (RMS) of the first iteration. The initial model is then updated based on the findings of the previous iteration. This process of updating the model and forward modeling and updating the model is carried out in several iterations and a final model is determined. Figure 7. Shows the final inversion after the removal of all noisy data.
